GARFIELD HEIGHTS PROJECT A CASE STUDY IN RUTTING CORRECTION

High Stress HMA Pavement Cures Problem

The City of Garfield Heights is rehabilitating Broadway Street (SR 14). In planning the project the city's engineer, Wade-Trim of Ohio, sought suggestions from Flexible Pavements of Ohio on how best to correct the rutting, shoving and corrugations present on this heavily loaded street.

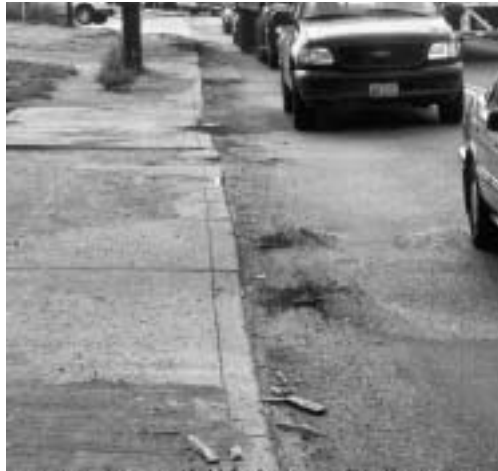
The existing asphalt surface on Broadway Street was severely deformed from traffic and distressed from age.

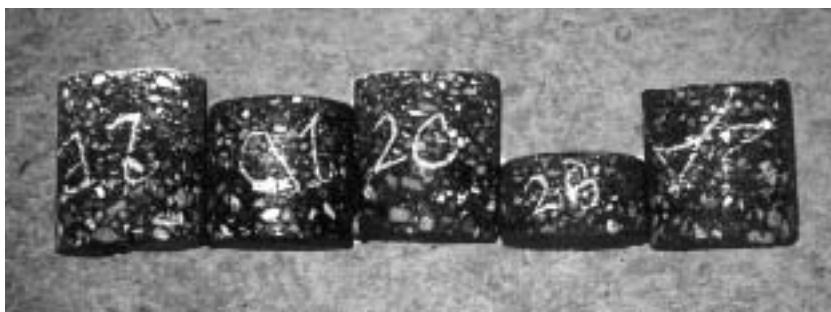
deformation. Five sets of cores were taken at different locations on the project. The set of cores at a single cross section consisted of a core at the point(s) of maximum rutting, a point of maximum heaving and at an area, which showed no visible deformation. Coring was taken to the surface of the brick. These cores were then analyzed to determine which layers of the pavement were deforming.

Observation of the cores revealed 3 distinct layers of bituminous concrete over the bricks. The bottom most layers appeared to be a type 2 gradation with slag aggregate and a coal tar binder. Over that were 2 courses of type 1 mix with natural sand and gravel aggregate and asphalt binder. The overall thickness of the cores recovered varied from 2-1/4 inches to 4-3/4 inches. All the bituminous concrete layers showed deformation. All but one of the cores came cleanly off the brick, indicating little or no bond to the underlying bricklayer.

Comparison of cores taken across one lane show the extent of the deformation that has occurred.

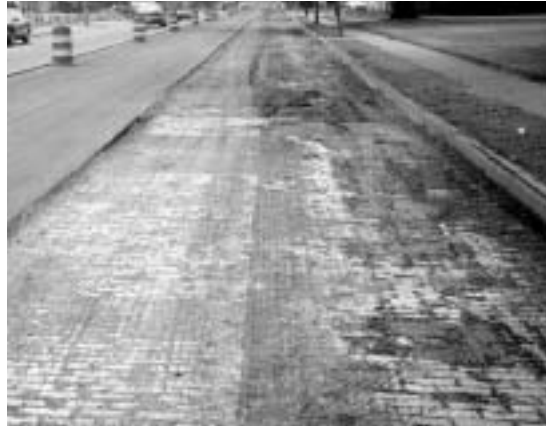
Severely distressed asphalt is milled to the bricks in the curb lane while the center lane is milled for a single course inlay.

On the balance of the project, Garfield Heights is using a more modest rehabilitation consisting of removal of the bituminous concrete overlay from the surface of the bricks, leaving the bricks in place. On this they are placing a heavy tack coat, 0.2 gal/sigh of rubberized liquid asphalt, 702.13, 2-1/2 inches of 446, type 2, PG76-22M and 1-1/2 inches of 446 type 1, with polymer and fiber modified binder. In the center lanes where deformation is negligible,

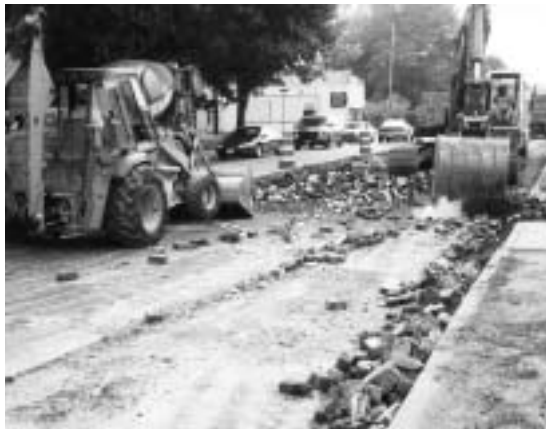
Removal of the bricks down to the 9-inch concrete base proceeded rapidly.

Paving Company in the spring of 2001 and work began on June 16th. Based on funding constraints and conditions, Garfield Heights chose to remove the bituminous concrete and bricks from I-480 to the south end of the bridge 5,000 feet north of I-480. After concrete base repair, the project will place 8 inches of new asphalt concrete consisting of 4 inches of 301, 2-1/2 inches of 446, type 2, and 1-1/2 inches of 446, type 1H. The surface and intermediate courses will have polymer-modified binders, PG76-22M.

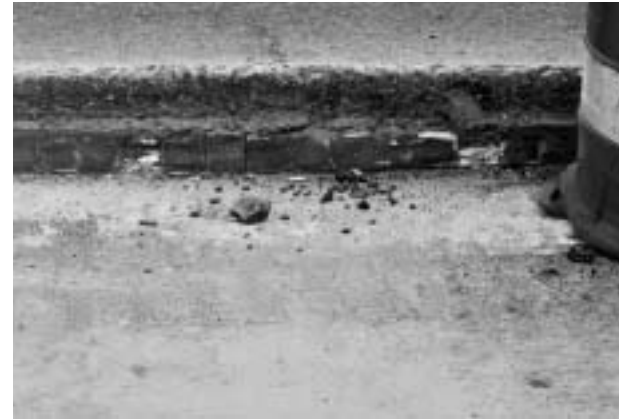
Removal of the asphalt surface and bricks leaves room for 8 inches of new, rut-resistant asphalt.
